Report prepared by: Lloyd Ssentongo "NIH/NIAID/OCICIB site lead Uganda and coordinator of the solar installations below."

Summary report on the installation of solar power at the various NIH sites in Uganda.

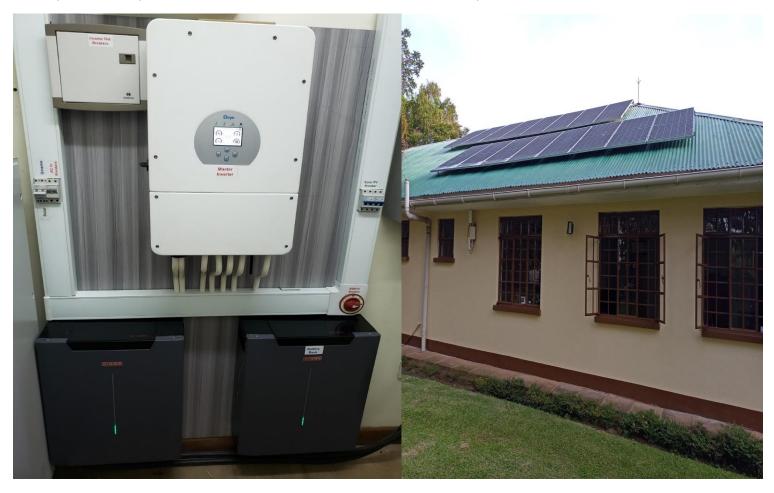
Below photo: Solar plant for Entebbe NIH block, the inverters and battery.

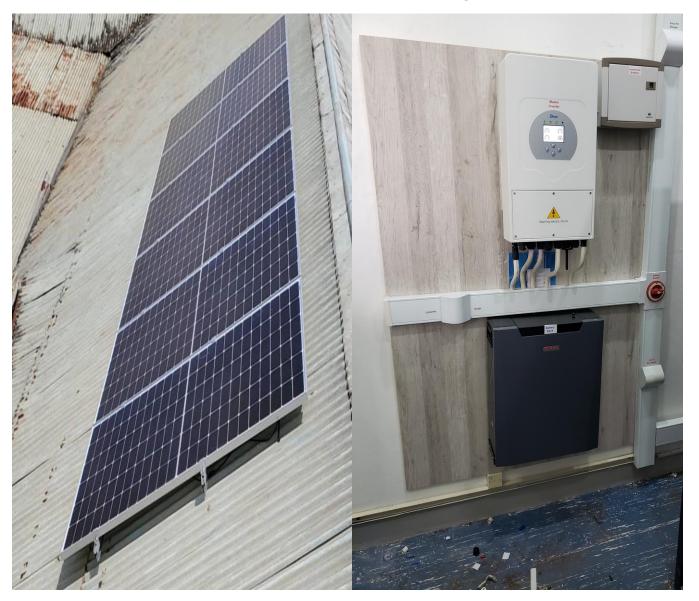
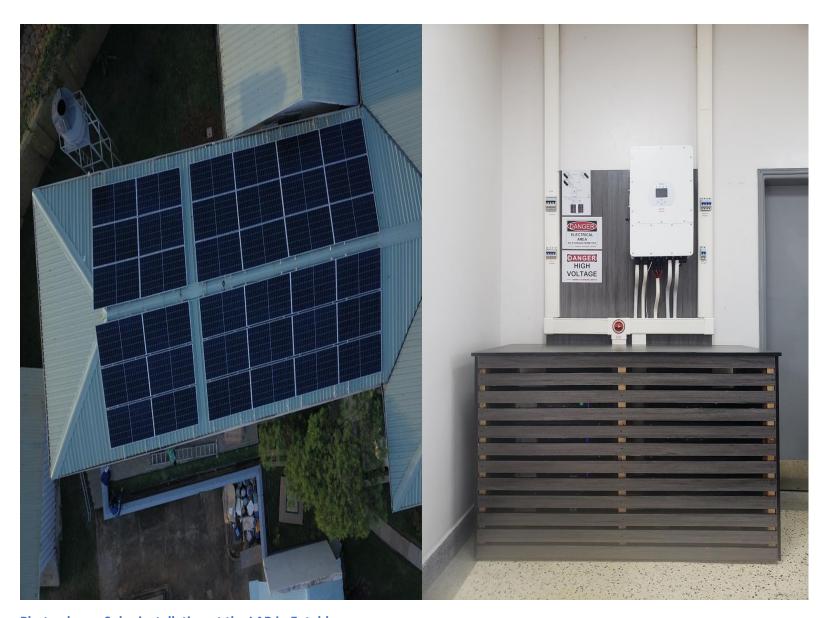
Photos below for Entebbe data Center and the solar installation feeding it.

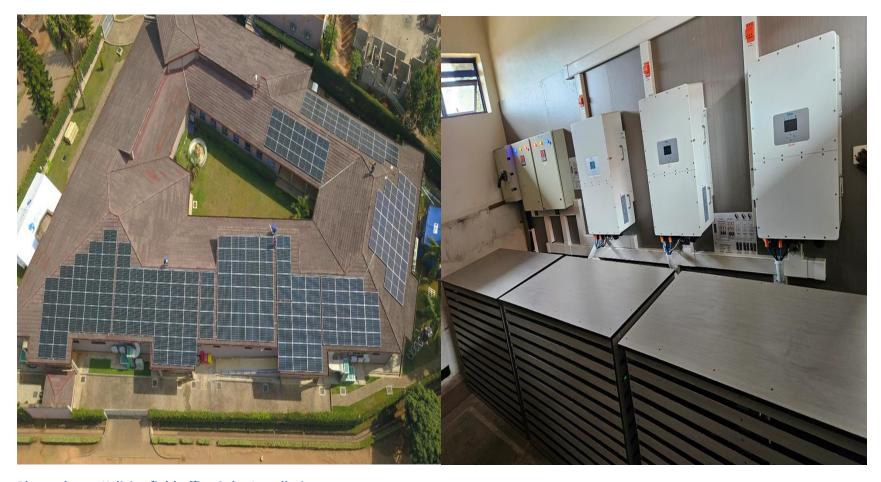
Photo above: Kalisizo field office Solar Installation
